Electrical Engineering

Introduction

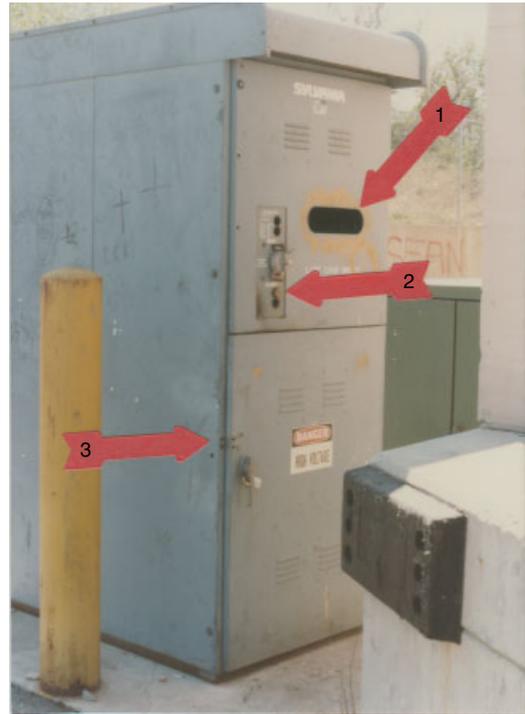
Figure 1 Figure showing the front doors on the high-voltage disconnect switch. Arrow 1 indicates the missing cover over the observation window of the switch. Arrow 2 indicates a lock with a key broken off in it, which is shown in more detail in Figure 2. Arrow 3 indicates holes in the fuse compartment door, which is shown in more detail in Figure 3

liable for electrical damage or injury on their property and the injury occurred on supermarket property. A group of children had been playing behind a closed supermarket where a 13 kV switch was located near a loading dock (Figure 1). The engineer was asked to determine why the injury occurred; if the electrical equipment was properly installed, maintained, or manufactured and if not, what parties were at fault. At the injury location, the engineer saw that the switch did not have a fence or additional enclosure around it, as required by electrical standards [15]. This indicates that the switch was improperly installed by the supermarket's contractors. The observation opening on the front of the switch was missing a cover to keep water out, arrow 1 in Figure 1. The switch operating handle was in the closed position, arrow 1 in Figure 2. A key was broken off in a lock that was mechanically linked with the position of the switch, arrow 2 in Figure 2.

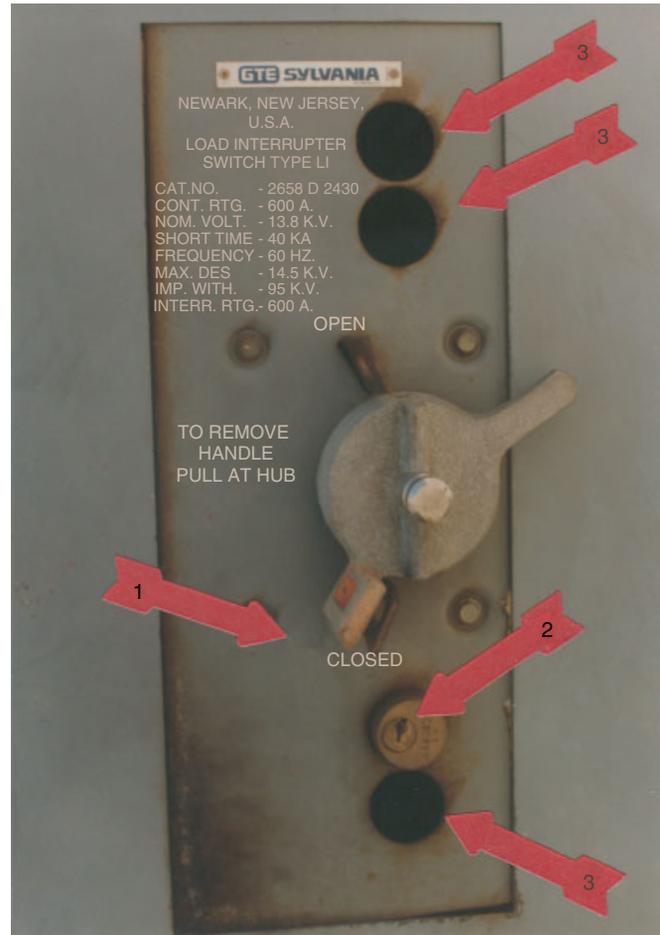
Figure 2 Figure showing the operating handle of the switch. Arrow 1 indicates that the switch is in the closed position. Arrow 2 indicates the broken key in the lock. Arrow 3 indicates unsealed openings

Normally, the key can only be removed from the lock when the switch is in the open position. When the switch is open, the key is removed from the lock and utilized to unlock another lock, which is securing the lower door of the switch where fuses are located. Additional unsealed openings were found around the switch handle, arrow 3 in Figure 2. The switch's lower fuse compartment door had holes in it where a lock that was controlled by the broken key should have been located, arrow 3 in Figures 1 and 3. This indicates that the switch was not properly maintained by the supermarket. Subsequently, the fuse compartment of the switch could be opened and entered while the switch was energized with 13 kV. Evidence of burning, arcing, and melted metal was found at the

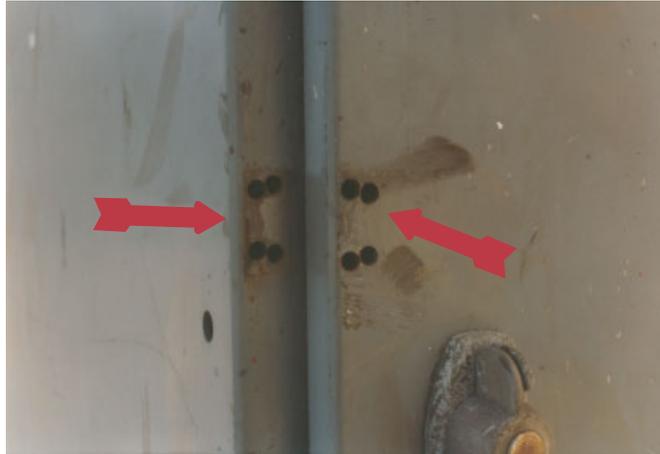
Figure 3 Close-up figure showing the holes in the door of the fuse compartment and frame of the switch, as indicated by the arrows in the Figure

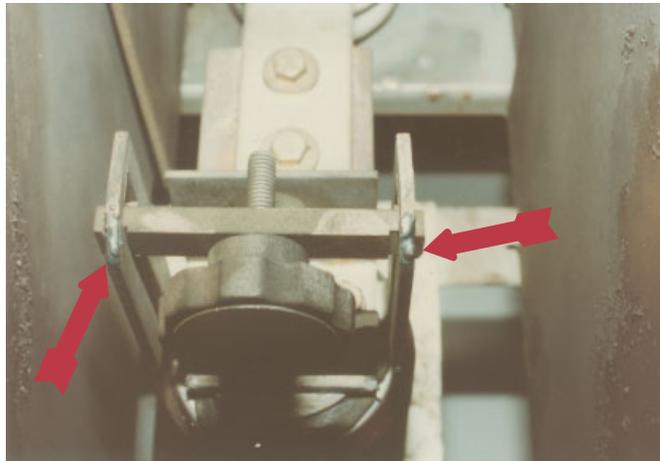
Figure 4 Close-up figure showing the melted metal at the top of the fuse holder, as indicated by the arrows in the Figure

top of the left fuse holder in the fuse compartment (Figure 4). This is where the child's right hand made contact with 13 kV. Fingerprints in metal were found on the left side of the fuse compartment opening (Figure 5). This is where the electrical current exited the boy's left hand. The electrical current flowed from the top of the fuse holder through the boy's arms to the side of the switch, which is grounded as required by electrical codes. This injury was caused by the improper design, installation, and maintenance of the high-voltage disconnect switch, which violated electrical codes and standards. It was not designed for outdoor use. The openings in its enclosure permitted water and debris to enter into the switch. A single-door design covering the fuse compartment

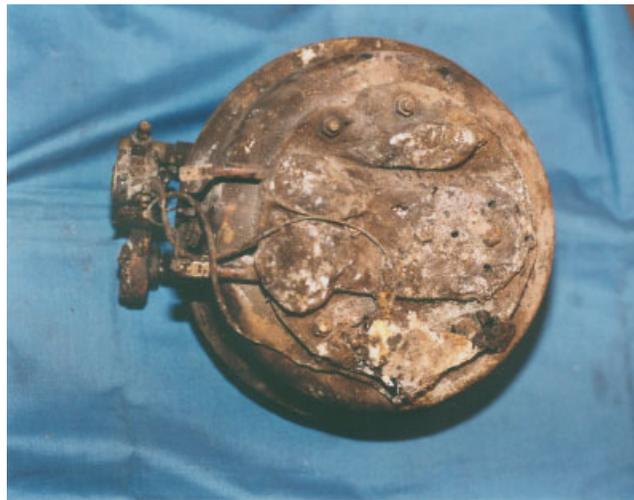
Figure 6 Figure showing the bottom of the steam generating tank

cause of a fire. He also emailed photographs of the fire scene and his fire determination report to the engineer. Among the items was a severely heat-damaged steam generating tank (Figure 6). The steam generating tank was X-rayed (Figure 7). The X-ray showed that the sheath (exterior enclosure) of the unit's

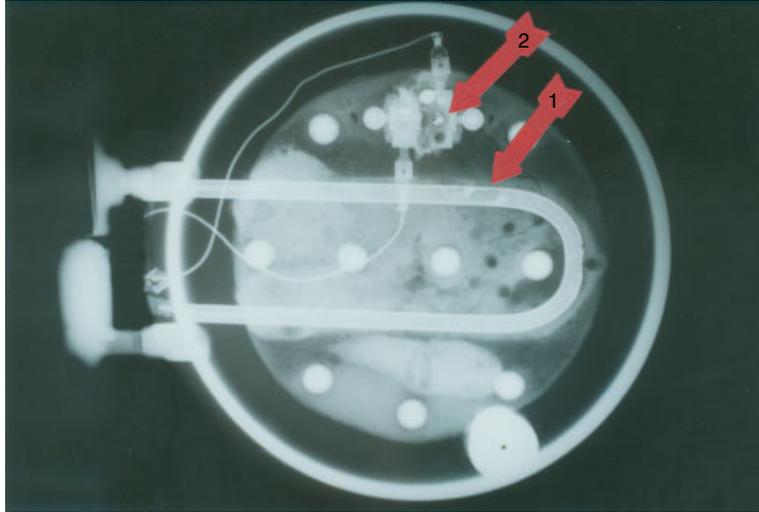
Figure 7 Figure showing an X-ray of the steam generating tank. Arrow 1 indicates an opening in the sheath of the heating element. Arrow 2 indicates a thermal control device

heating element was open (arrow 1 in Figure 7) and a thermal over-temperature device had blown apart (arrow 2 in Figure 7). In addition, the nichrome wire inside the heating element was separated and disintegrated in many locations (Figure 8). The nichrome wire is the device that generates heat inside the

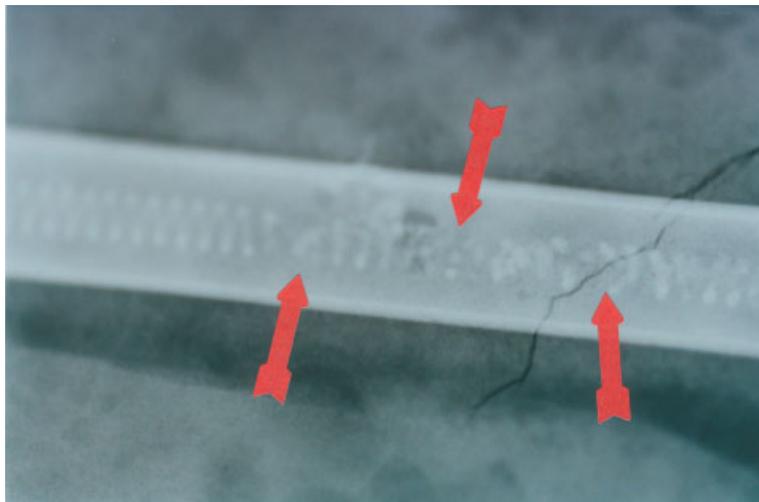
Figure 8 Close-up figure showing the nichrome wire inside the heating element, as indicated by the arrows in the Figure

heating element when electric current passes through it. Nichrome wire is a nickel-base alloy, containing chromium and iron. Nichrome wire has a melting point of 1020–1452°C depending upon the chemical composition of the alloy [16]. The fire temperatures in a residential building normally do not exceed 800°C. Subsequently, the disintegration of the nichrome wire inside the heating element indicates that the heating element malfunctioned and caused the fire. The

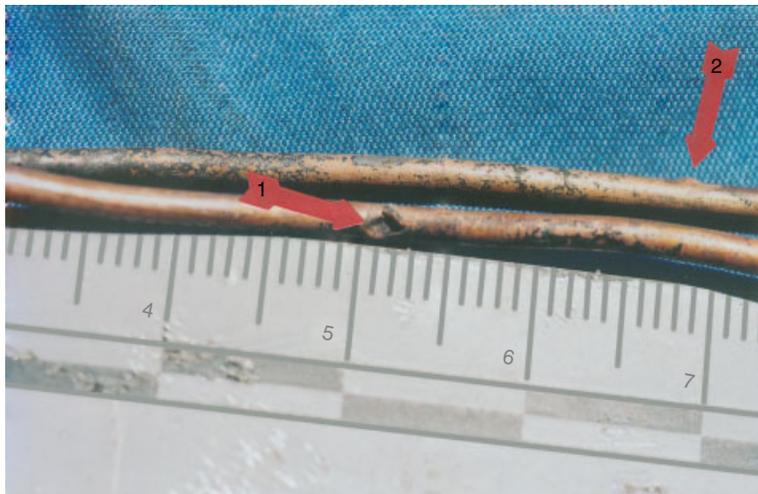
Figure 9 Figure showing copper wires with melted areas. Arrow 1 indicates a melted area shown in more detail in Figure 10. Arrow 2 indicates a melted area shown in more detail in Figure 11

Another case involved a large residential building that sustained fire damage while \$500 000 worth of renovations was being performed. An electrical engineer was retained to investigate the origin and cause of a fire along with a fire investigator and mechanical engineer for subrogation purposes. The building had experienced electrical problems and the fire was discovered just after the building's new fireplace was lit for the first time. The fire originated within the walls of the building where electrical wiring was located. The origin was in the concealed space above the new fireplace. Electrical wiring was located there to supply electrical power to an outlet on the right side of the fireplace. The wiring was solid copper and evidence of melting was found <2 cm apart on two wires (Figure 9). Melted copper between two electrical wires quite frequently indicates that the two wires short-circuited together. When copper wiring short circuits, it generates temperatures exceeding 1200°C with sufficient energy to ignite most common combustibles. However, the evidence of melting is normally at the same location along the length of the wire. Microscopic inspection of the melted areas

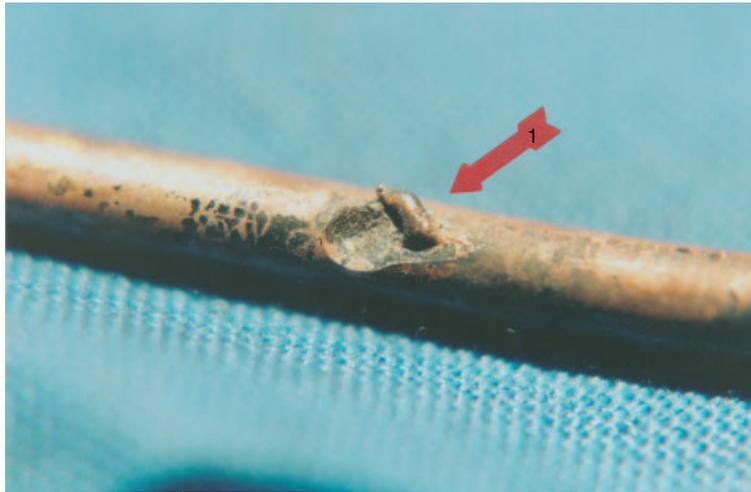
Figure 10 Close-up figure showing the melted area indicated by arrow 1 in Figure 9

found that they were bite marks (Figures 10 and 11). Subsequently, an animal bit the wiring and produced the short circuit, which ignited the building. The fire was the result of the renovation contractor leaving openings to the interior of the walls unsecured during construction after electrical power was supplied to the building. The engineer determined the origin and cause of the fire and the party at fault, the renovation contractor. However, no litigation followed because the building owner had signed a contract with the renovator that eliminated their liability for damages that occurred during the renovation.

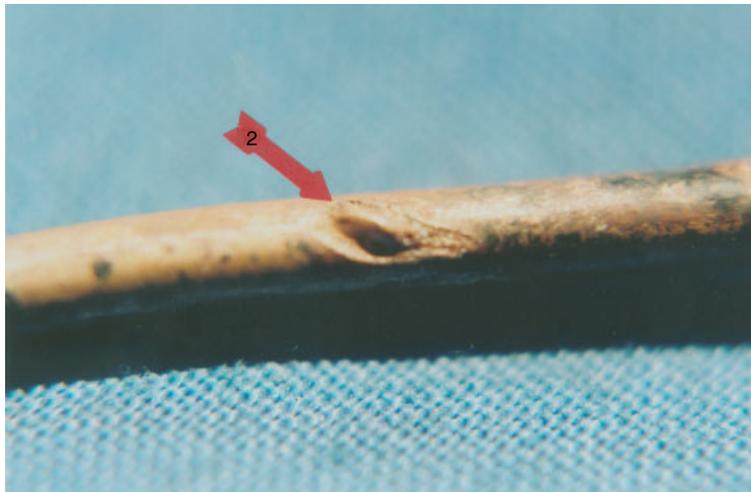
Figure 11 Close-up figure showing the melted area indicated by arrow 2 in Figure 9

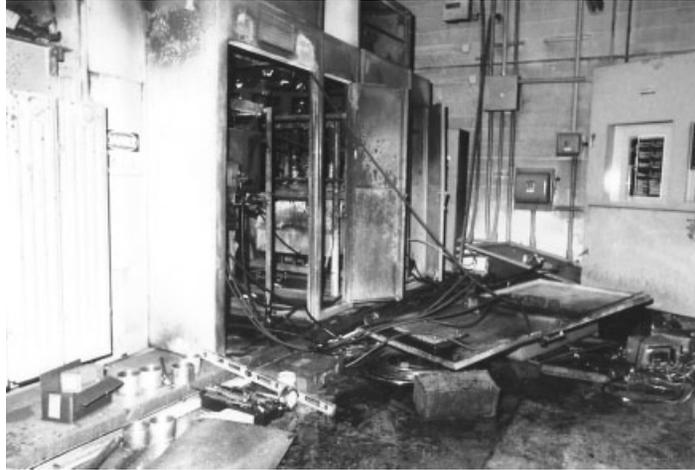
Figure 12 Figure showing where an explosion occurred in an electrical room

Another example of an electrical injury case involves an electrical explosion in an electrical distribution room that caused electrical injury and severe property damage (Figure 12). The engineer was asked by a law firm to inspect the scene of the explosion, evidence retained from the scene and research documents to determine the cause of the explosion and the parties at fault for causing the personal injuries of workers. The oil within a 5000-V oil circuit breaker had exploded and ruptured its tank (Figure 13). The explosion occurred when the oil circuit breaker was closed after maintenance was performed on it. The maintenance personnel were only permitted 30 min to work on the circuit breaker. Their maintenance consisted of draining the oil out of the bottom of circuit breaker and pumping new oil in. However, proper maintenance on this type of oil circuit breaker requires a minimum of two

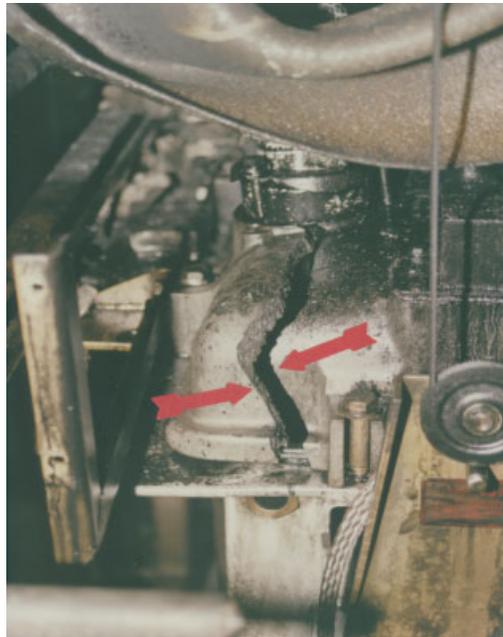
Figure 13 Figure showing where the tank of the circuit breaker ruptured

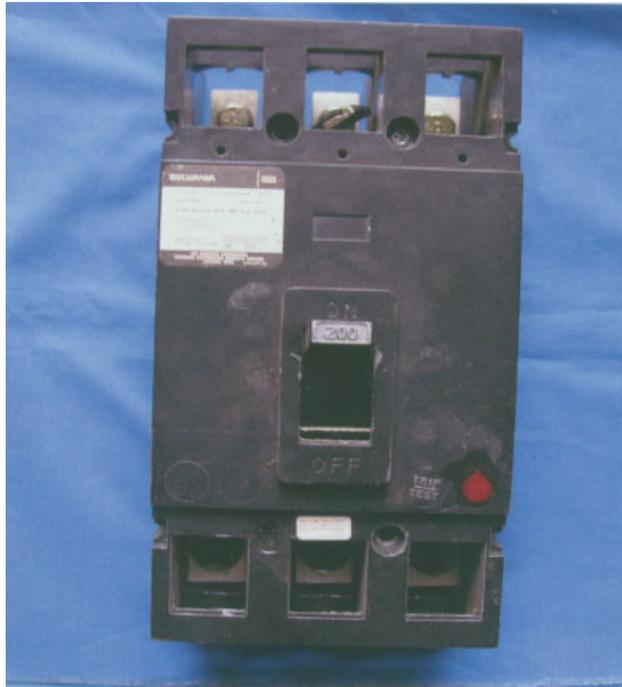
Figure 14 Figure showing the exterior of the circuit breaker

the exterior of the circuit breaker (Figure 14). Preliminary tests of the circuit breaker indicated that two of the phases (circuits) inside the circuit breaker were open even when its operating handle was in the closed position. The circuit breaker was X-rayed. The X-ray showed that internal components of two phases of the circuit breaker had separated and melted (Figure 15). The engineer reported the results of the inspection, testing and X-rays to the insurance company adjuster. A report was requested with Figures and X-rays. The manufacturer of the defective circuit breaker was put on notice of the financial loss. Subsequently, the circuit breaker was disassembled with representatives of its manufacturer present. The

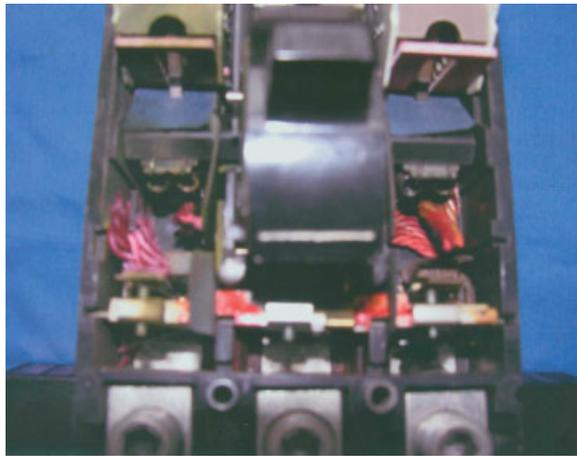
Figure 16 Figure showing the interior of the circuit breaker after disassembly

internal examination of the circuit breaker confirmed what the X-rays showed (Figure 16). An exemplar circuit breaker was disassembled to compare internal components. The components that melted and separated in the other circuit breaker were much lighter in color (Figure 17). The difference in color indicates that the separated components had overheated. The circuit breaker should have opened before its components melted and separated. A circuit breaker is “a device designed to open and close a circuit by non-automatic means and to open the circuit automatically on a predetermined overcurrent without damage to itself when properly applied within its rating”. The circuit breaker “is provided to open the circuit if the current reaches a value that will cause an excessive or dangerous temperature in conductors or conductor insulation” [17]. The purpose of the main circuit breaker is to open and disconnect electrical power from an electrical distribution panel and the circuit feeding it before the malfunction produces sufficient heat to ignite a fire in a building. Consequentially, the fire was caused by a defective main circuit breaker. The engineer answered the technical questions about the origin, cause, and party at fault for the fire damage, the circuit breaker manufacturer. The case was settled after disassembly of the circuit breaker with representatives of the circuit breaker manufacturer present, engineers, and attorneys.
